CASE REPORT

Digital Esthetic rehabilitation using Porcelain Veneered Zirconia: A clinical case report

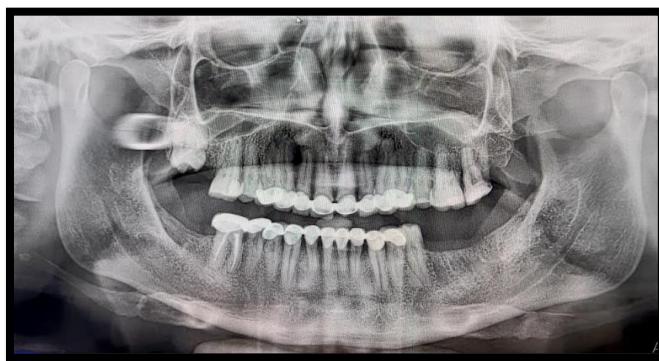
FIGURE 1- ORTHOPANTOMOGRAM REMOVAL OF PFM BRIDGE

Intra-oral examination showed fixed dental restorations from 14 to 24 and from 34 to 46 with generalized marginal gingival inflammation. The patient was also diagnosed as partially edentulous with respect to 17, 36, 37, and 47. Radiographic examination revealed an erupting 18, endodontically treated 46, and the rest of all teeth were vital. Multiunit fixed dental prostheses can be seen on orthopantomogram from 14 to 24 and 34 to 44, and separate two-unit fixed prostheses on 35 and 36 (Figure 1).

functional demands. Thus, the final treatment plan for this patient included the removal of the previously placed porcelain fused to metal bridge from 14 to 24 and 34 to 44, refining the preparations, and fabrication of zirconia crowns for all the involved teeth.

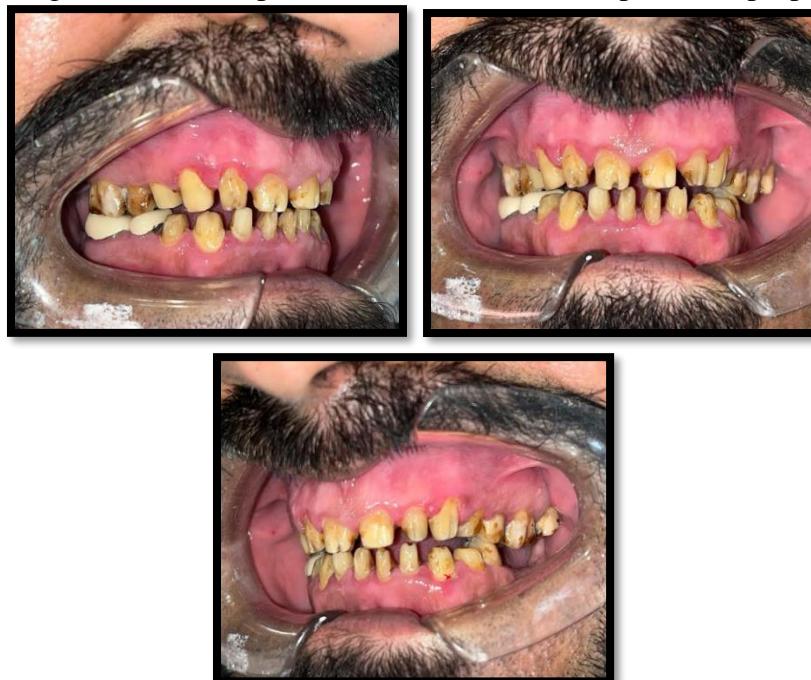
FIGURE 2- INTRAORAL VIEWS AFTER REMOVAL OF PFM BRIDGE

Fixed dental prostheses were removed in both upper and lower arches according to the treatment plan (Figure 2) and, the patient was referred for complete oral prophylaxis.

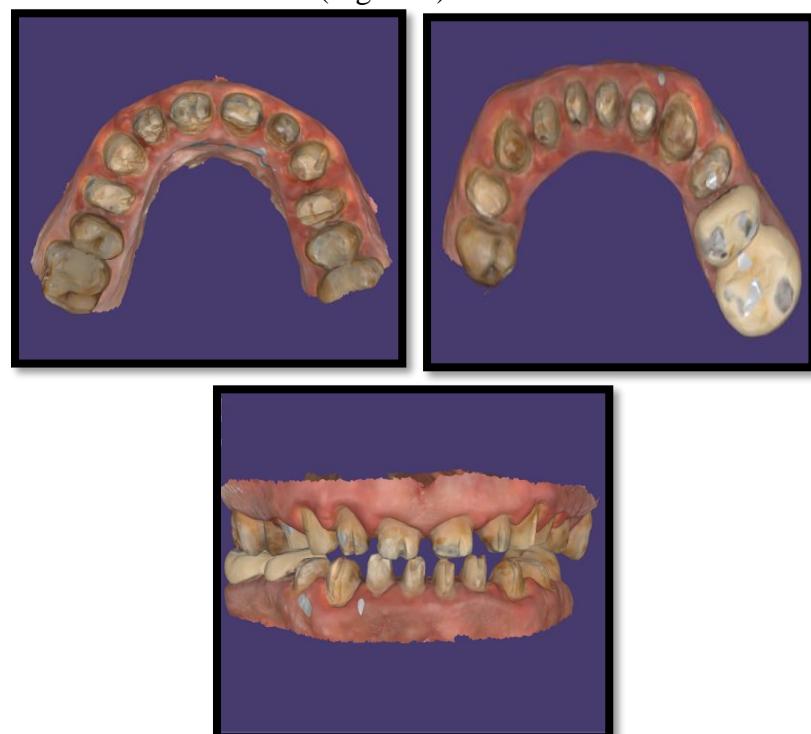
FIGURE 3- JAW SCANS

Subsequently, maxillary and mandibular arch scans were made using an intraoralscanning device (Medit i700), and the scanned data obtained was exported electronically to the digital labusing Exocad DentalCAD software (Figure 3).

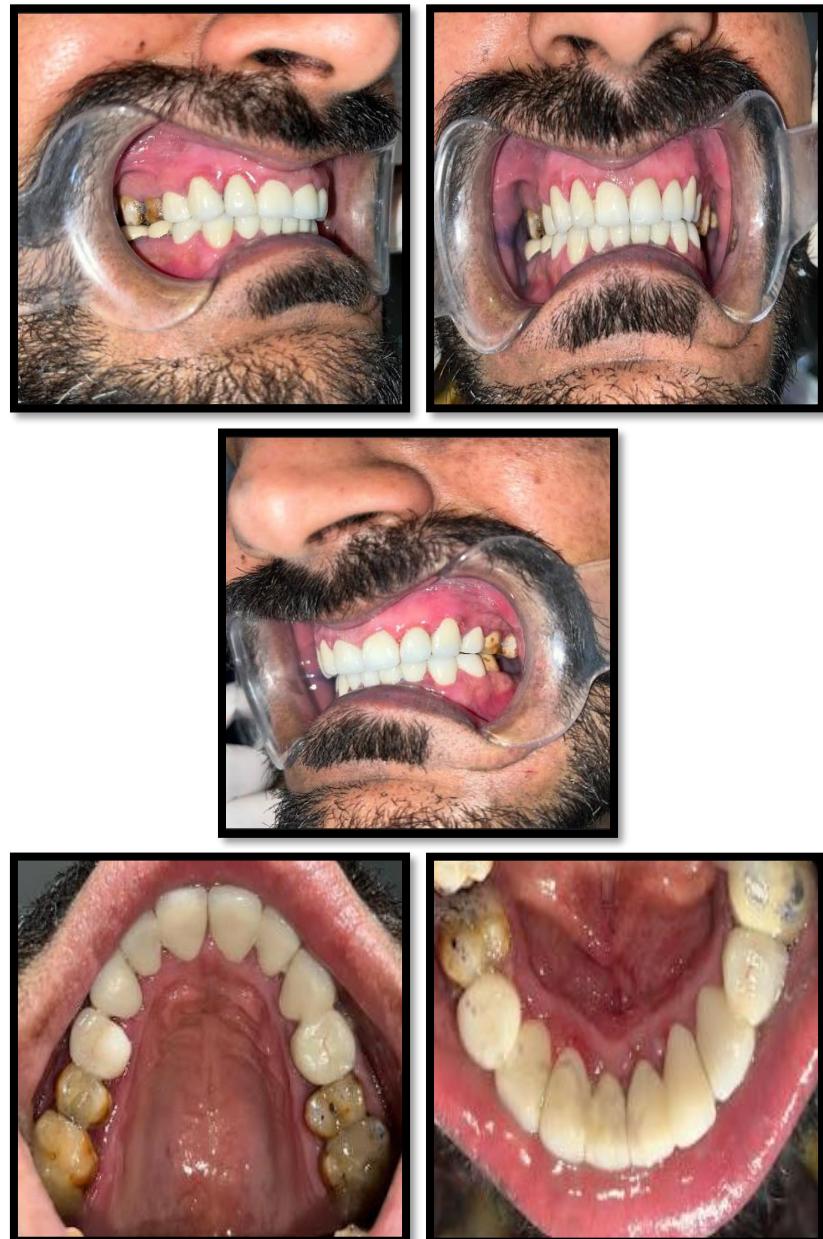
FIGURE 6- FINAL CEMENTATION

After the coping trial was done, the porcelain layers were added to the zirconia coping. On the final visit, the occlusal evaluation was done in centric and eccentric positions and all sixteen zirconia crowns were cemented with resin-modified glass ionomer cement following proper bonding procedures. (Figure 6)

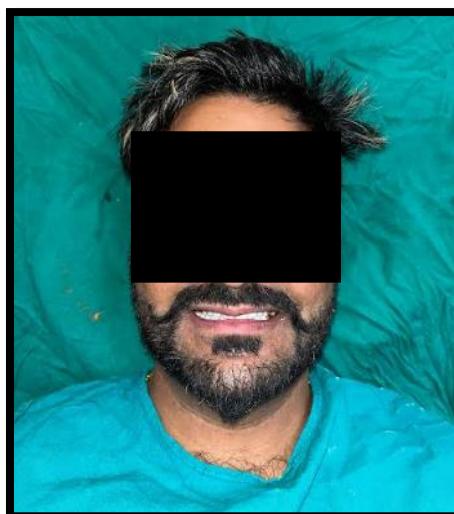
FIGURE 7- POST-OPERATIVE

The patient was extremely happy and highly satisfied with the final esthetic natural-looking result as per the patient's demand. The patient was recalled for subsequent follow-up visits.(Figure 7)
